**Project Report on
Automatic detection of
railway fasteners and track defects**

2018-03-26

(Diarienummer 2016-03306)

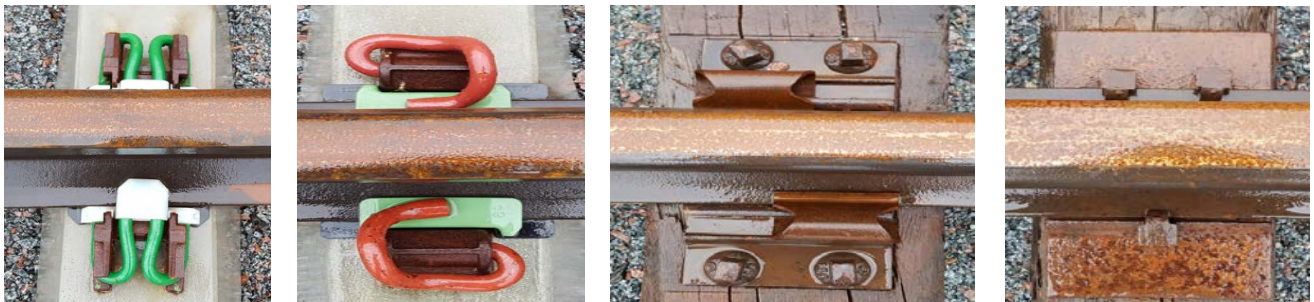
Common types of fastenings (Figure 3) are- fastening with rail spike with base plate above the tie, E-clip Fastening, Pandrol Fast Clip Fastening and Heyback fastening, the name of which may vary with locations

Pandrol Fast Clip

E- Clip Fastening

Rail Spike

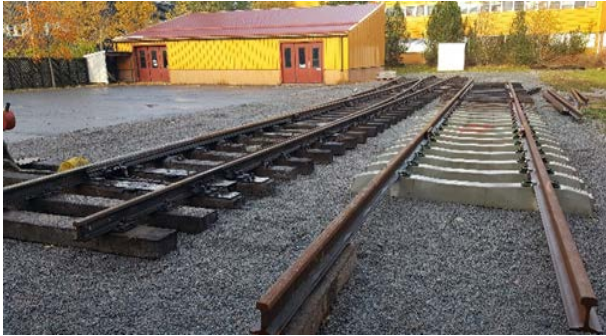
Figure 8 LTU test track

Measurements were carried out along the test track developed at Lulea University of Technology to investigate the response of the sensor to, different types of fastening systems (Refer Figure.3), presence of snow on the track. Measurements were also carried out to investigate sensor response to insulation joints along the track length.

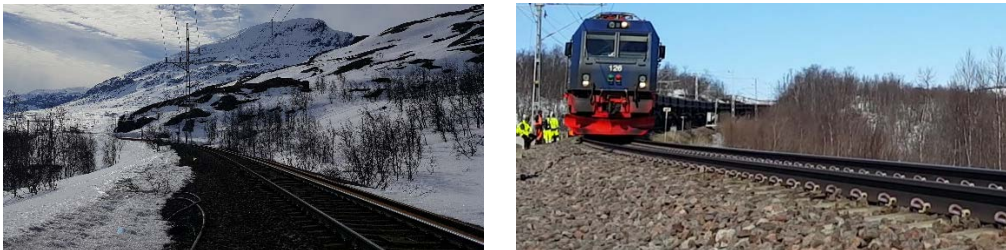
Figure 9 Iron ore line at Katterjåkk and Stordalen

Measurements were performed along the iron ore line at Katterjåkk and Stordalen, before and after grinding of the rail. These iron ore lines are located close to the Norway–Sweden border (close to Riksgränsen, one kilometre into Sweden). Figure 5 shows the iron ore line

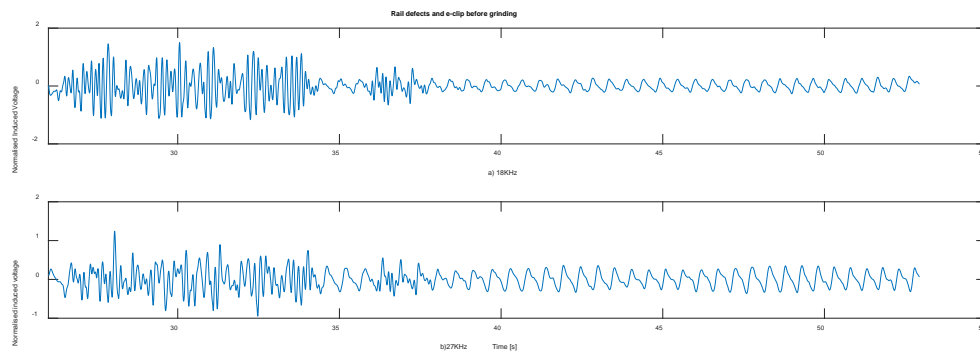
Figure 16 before grinding, Time signal: (a) 18 kHz Demodulation angle 83.3 degrees and (b) 27 kHz Demodulation angle 223.24 degrees, Measurement of a track section with defects on the track. All fasteners are in place.

Figure 17 Before grinding, I/Q plot of the demodulated signals: (a) 18 kHz Demodulation angle 83 degrees and (b) 27 kHz Demodulation angle 210 degrees, Measurement of a track section with defects on the track. All fasteners are in place.

Figure 16 shows the time signal of the measurement carried out for a cracked portion of the track before grinding. The cracks were found at the initial parts of the track (within first 30 sleepers). Individual clamps can be easily distinguished from both 18 KHz and 27 KHz plots, in the crack free parts. The cracks are visible in the time signal with higher magnitude. The demodulation angle was fixed at 83.3 degrees for 18 KHz and 223.24 degrees for 27 KHz to observe the clamp features. The IQ plot of the demodulated signal (Figure 17) shows that the healthy clamp features follow a pattern similar to Figure 11, but the cracks are superimposed to these clamp signals, modulated at a different angle.
